BULLETIN
BUL-027

MLT NAV/C2 Off Path Troubleshooting

This document presents field troubleshooting of the U.S. Navy Target Range's Moving Land Target (MLT) NAV/C2 units.

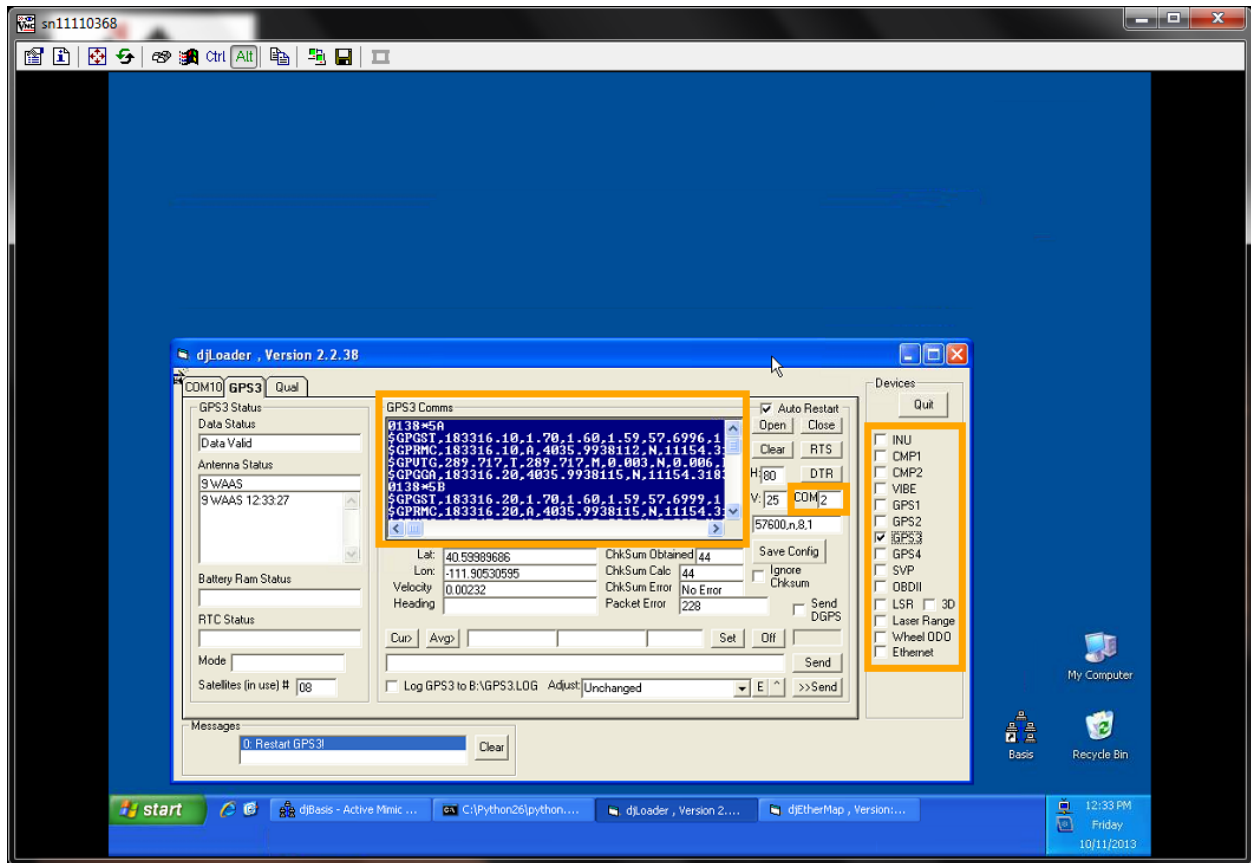
5. In the VNC window, close the command line window with the Vehicle Name and last 3 digits of the IP address as the title.
6. In the VNC window, restore djLoader. On the right-hand side, edit the checkboxes (see image on next page), as follows:

- Uncheck “OBDII”.
 - Uncheck “Wheel ODO”.
 - Check “GPS3”.
7. In the VNC window, in djLoader, on the “GPS3” tab verify data is streaming in the blue terminal area. If data is proceeding, continue with step 8. *If data is not streaming:*

8. In the VNC window, in djLoader, on the right-hand side, edit the checkboxes, as follows:
 - Uncheck “GPS3”.
 - Check “OBDII”.
 - Check “Wheel ODO”.
9. In the VNC window, restore the djBasis window. Under “Module Name” single-click on the “Vak.exe” entry, then click the “Execute” button.
10. Close the VNC window.
11. Verify GPS Correction is being received as documented previously in this bulletin.
